Rimkus Consulting Group, Inc.
Eight Greenway Plaza, Suite 500
Houston, TX 77046
(800) 580-3228 Telephone
(713) 623-4357 Facsimile

Re: RCG File No: 11009971
LLV Number: 0209452
VMF Location: 1530 Greensmark Drive in Houston, Texas
Subject: Final Report

Rimkus Consulting Group, Inc. was retained to examine LLV 0209452, VIN 1GBCS10E4M2908832. The fire occurred on June 13, 2016 at around 12:30 P.M. the operator of the vehicle at the time of the fire, was unavailable for interview but reportedly stated the vehicle's engine died while delivering mail on his route and backfired during subsequent attempts to restart it. Soon thereafter, smoke was observed from beneath the hood as well as flames.

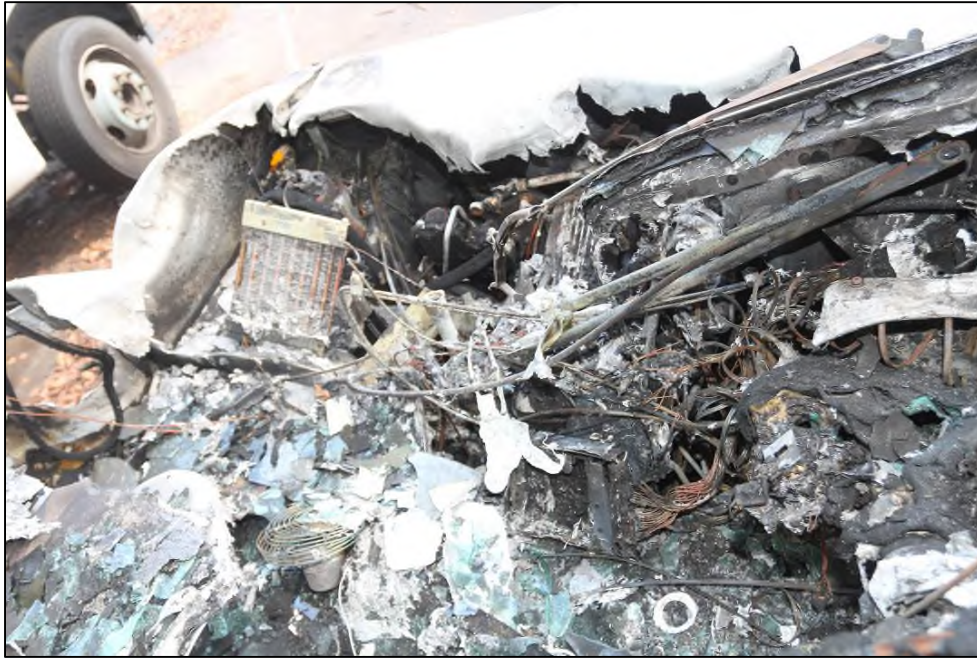
Photograph 5

A view of the dashboard and mail compartment.

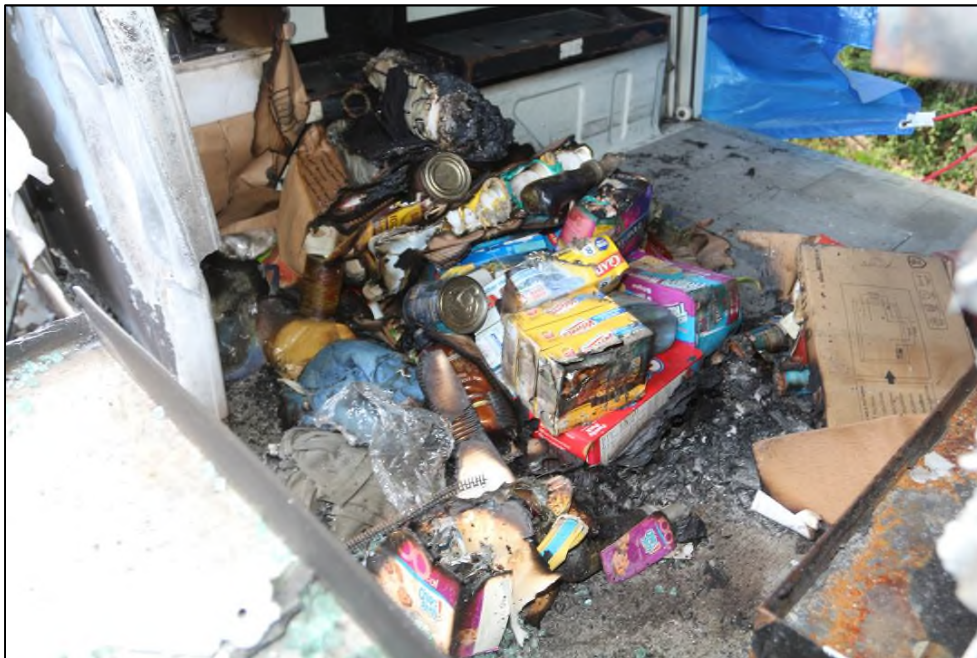
Photograph 6

A view into the mail compartment area.

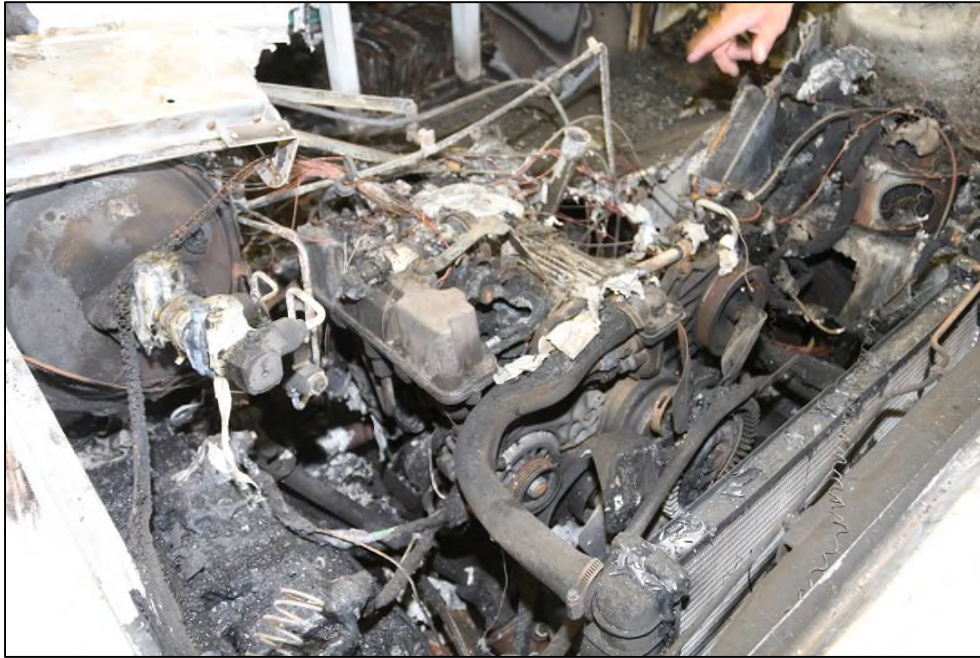
Photograph 7

A view of the engine compartment.

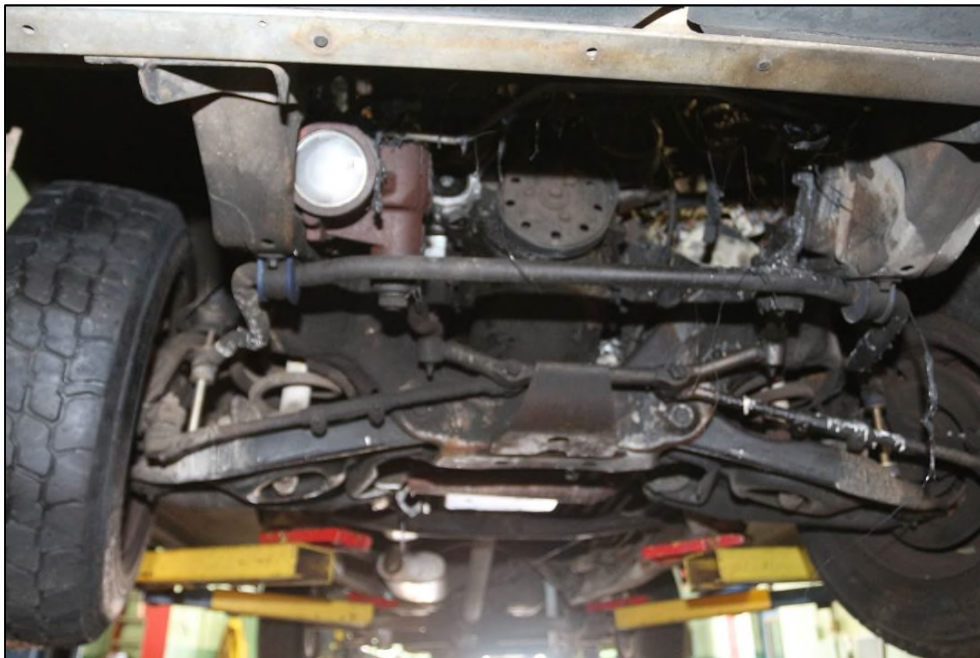
Photograph 8

A view of the undercarriage.

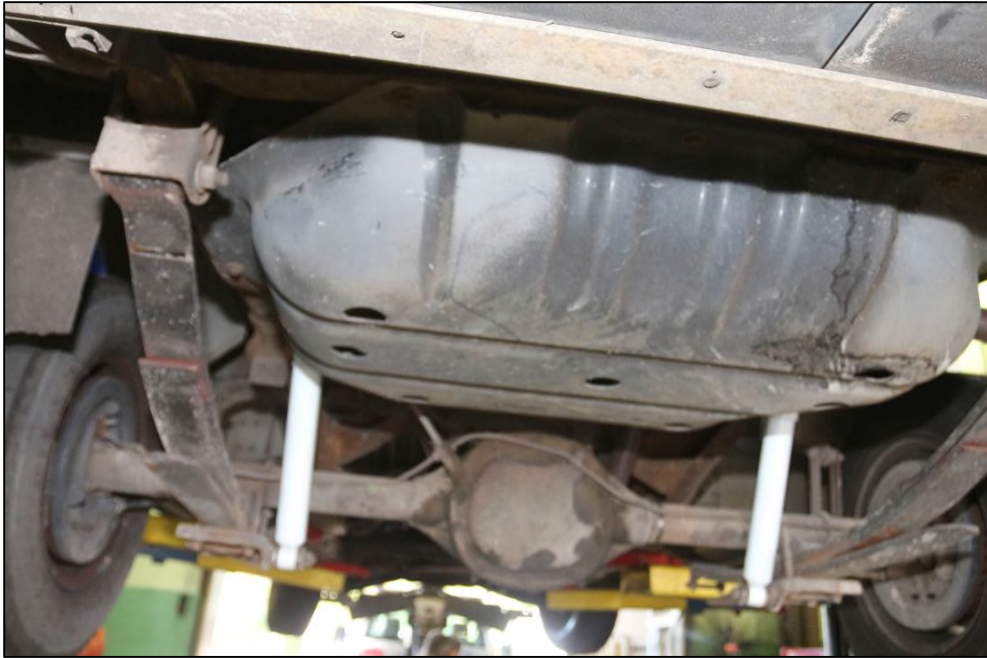
Photograph 9

An additional view of the undercarriage area.

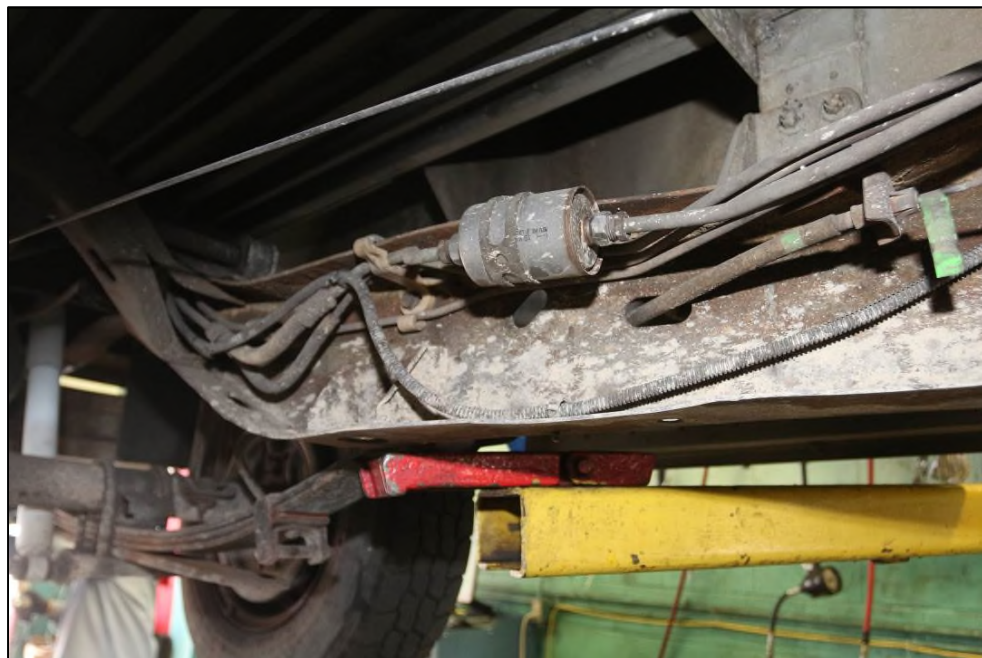
Photograph 10

A view showing the fuel filter found intact and undamaged.

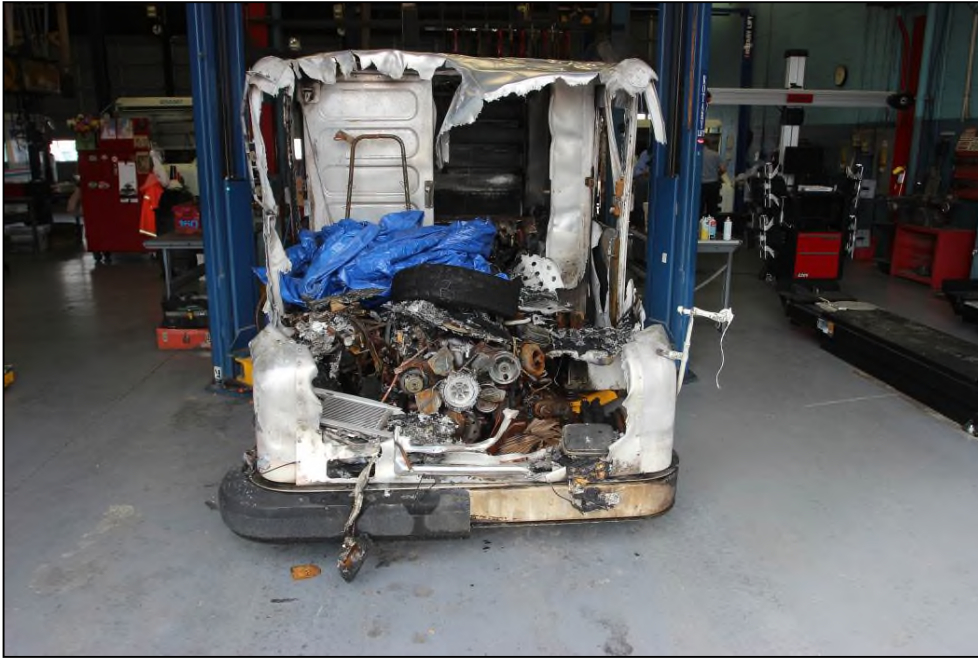
Photograph 1

View of the front of the vehicle.

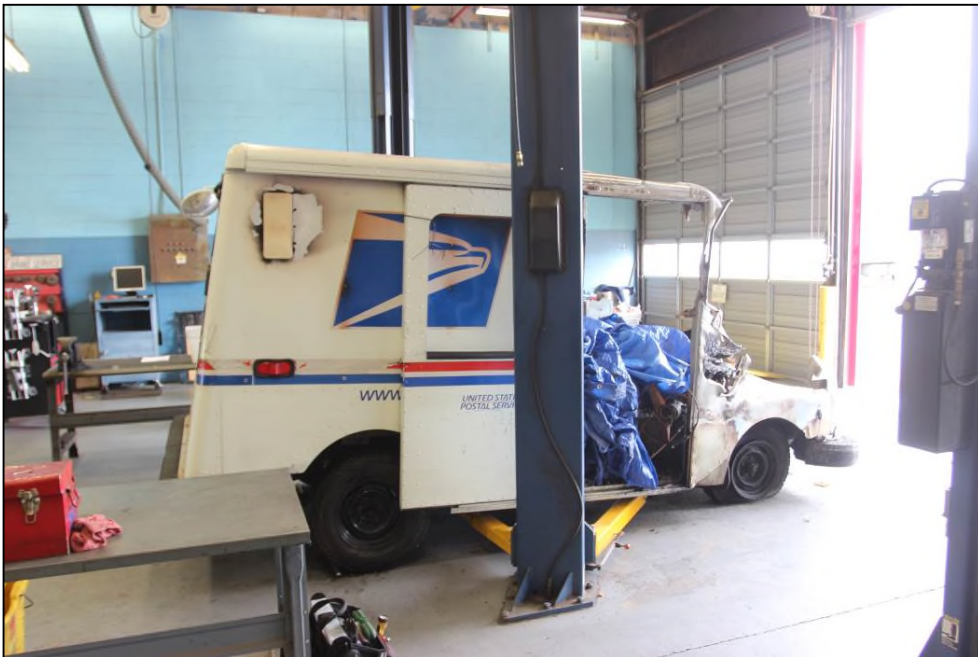
Photograph 2

A view of the driver's side.

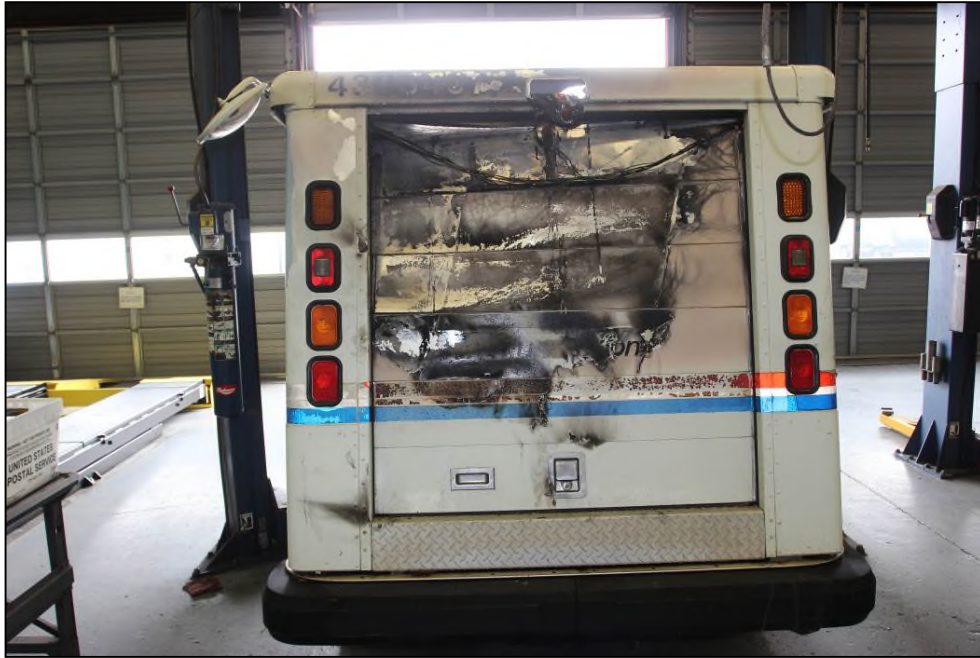
Photograph 3

A view of the rear.

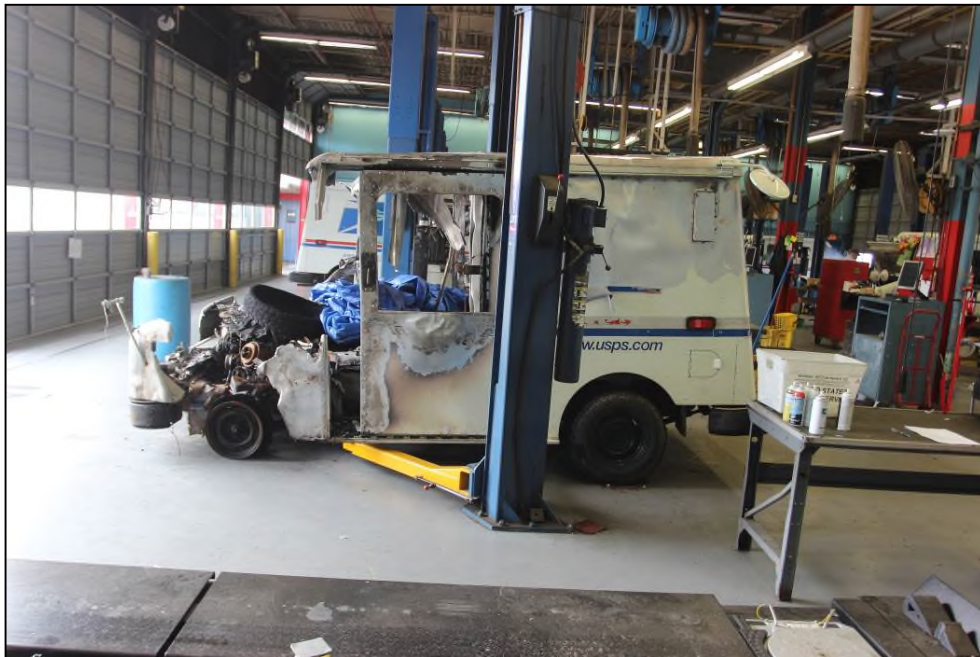
Photograph 4

A view of the passenger side.

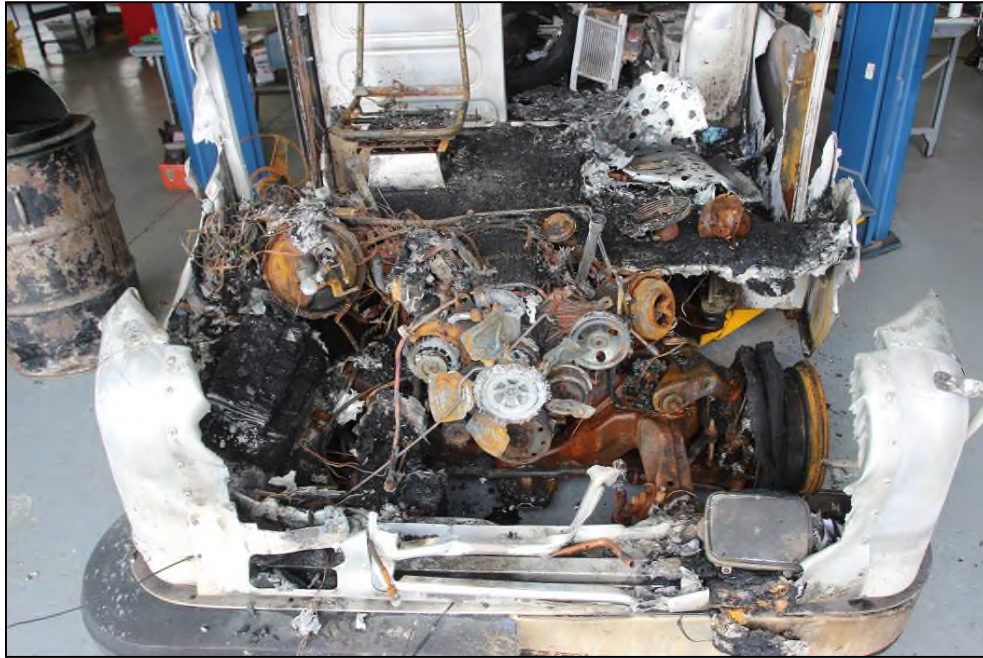
Photograph 5

A view of the engine compartment.

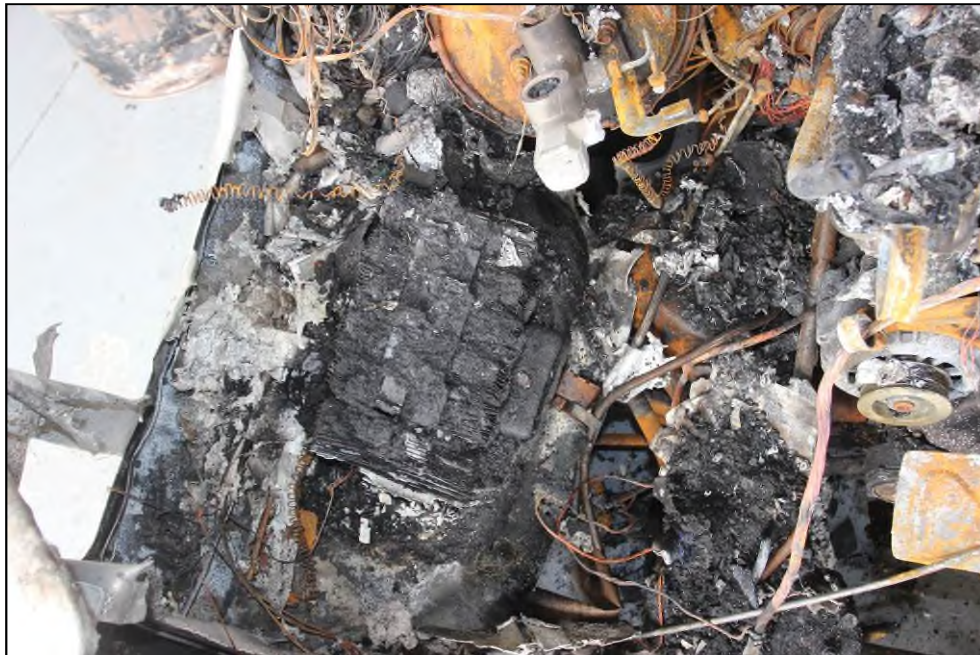
Photograph 6

A view of the battery which was damage from exterior fire attack.

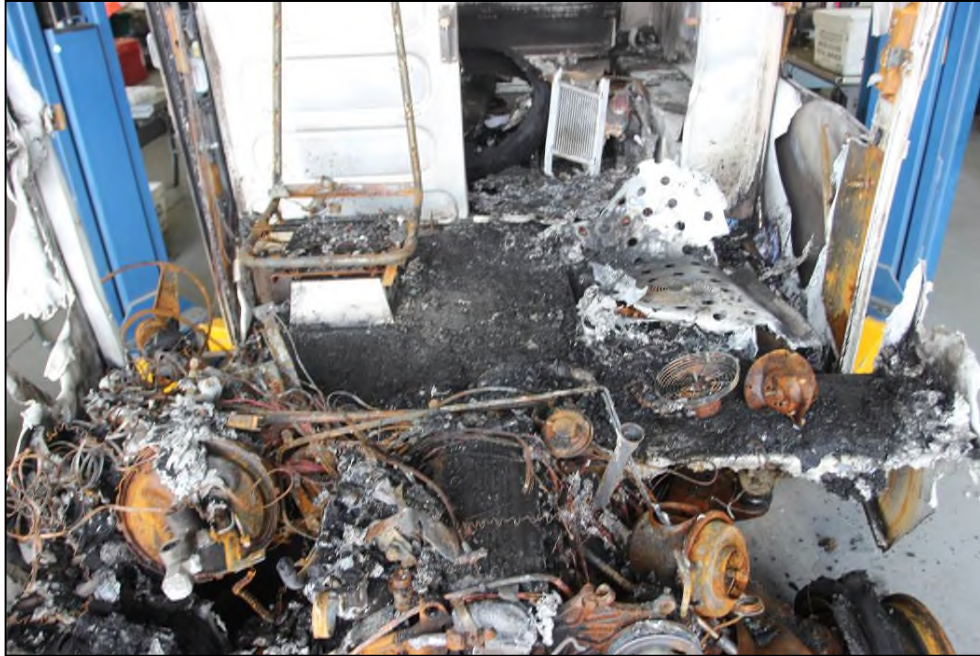
Photograph 7

A view of the rear of the engine compartment where the bulkhead was consumed during the fire event.

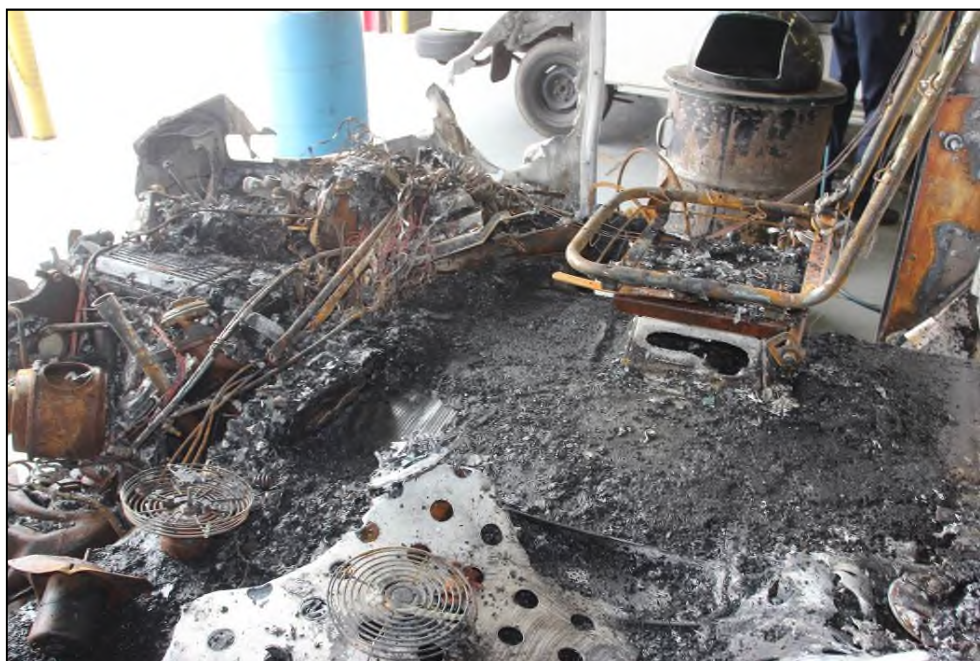
Photograph 8

A view of the floorboard area after debris removal.

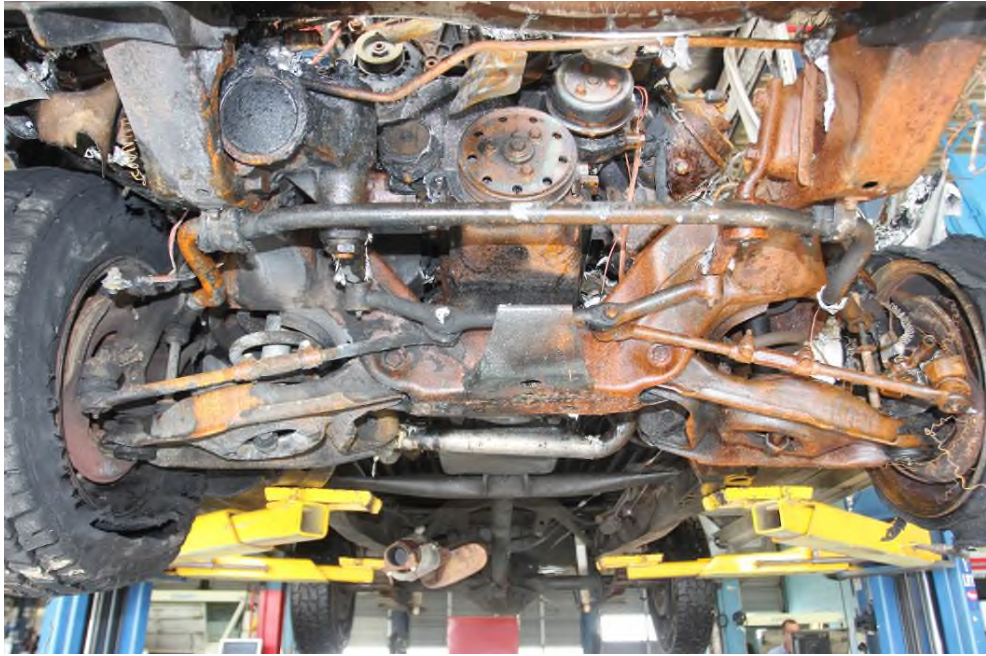
Photograph 9

A view of the front undercarriage area.

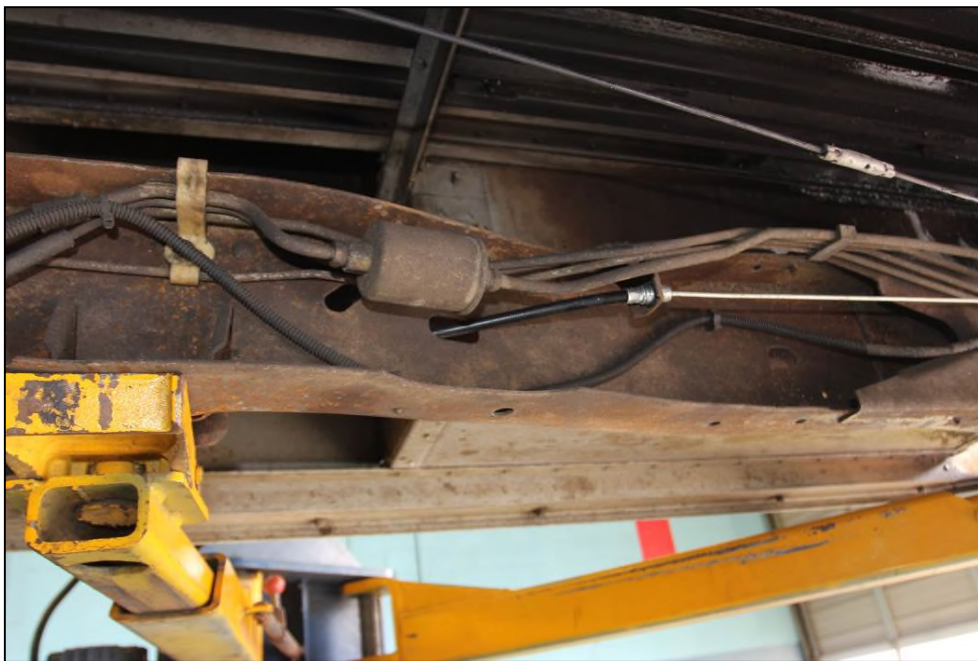
Photograph 10

A view of the undamaged fuel filter and fuel lines.

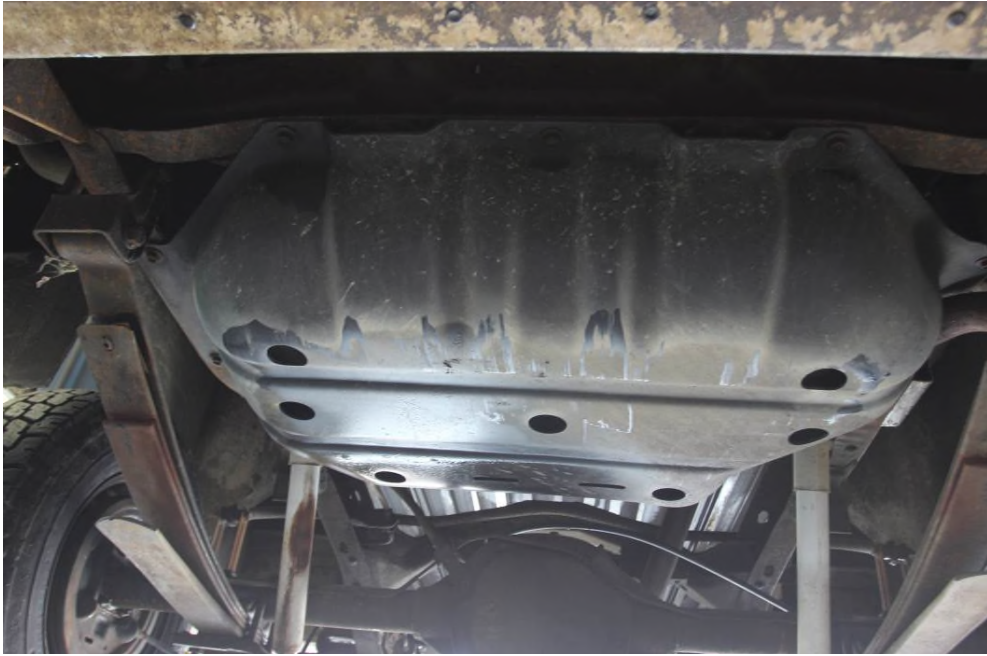
Photograph 11

A view of the undamaged fuel tank.

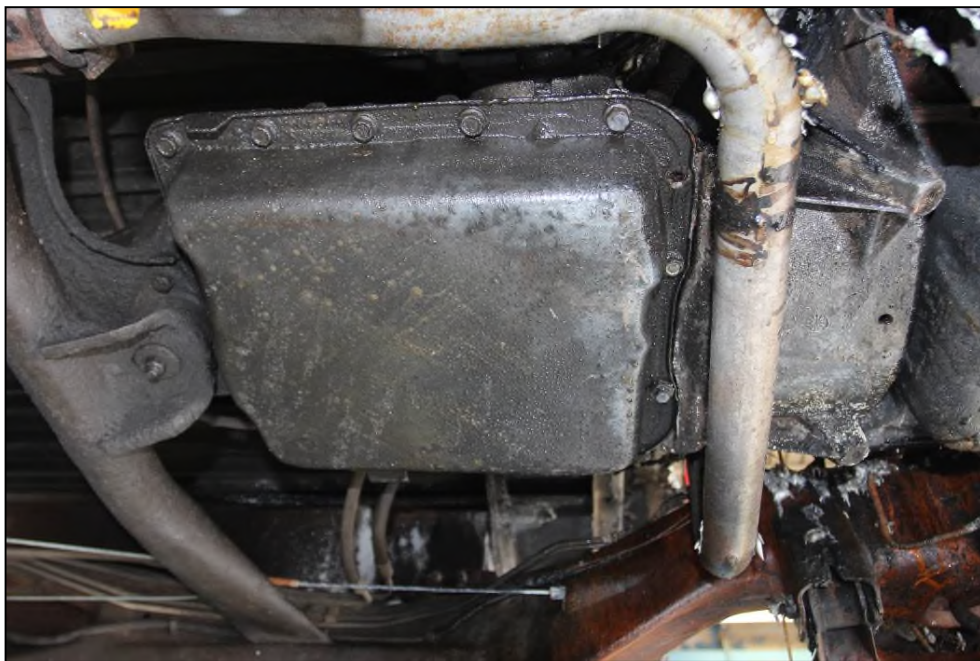
Photograph 12

A view of the undamaged transmission.

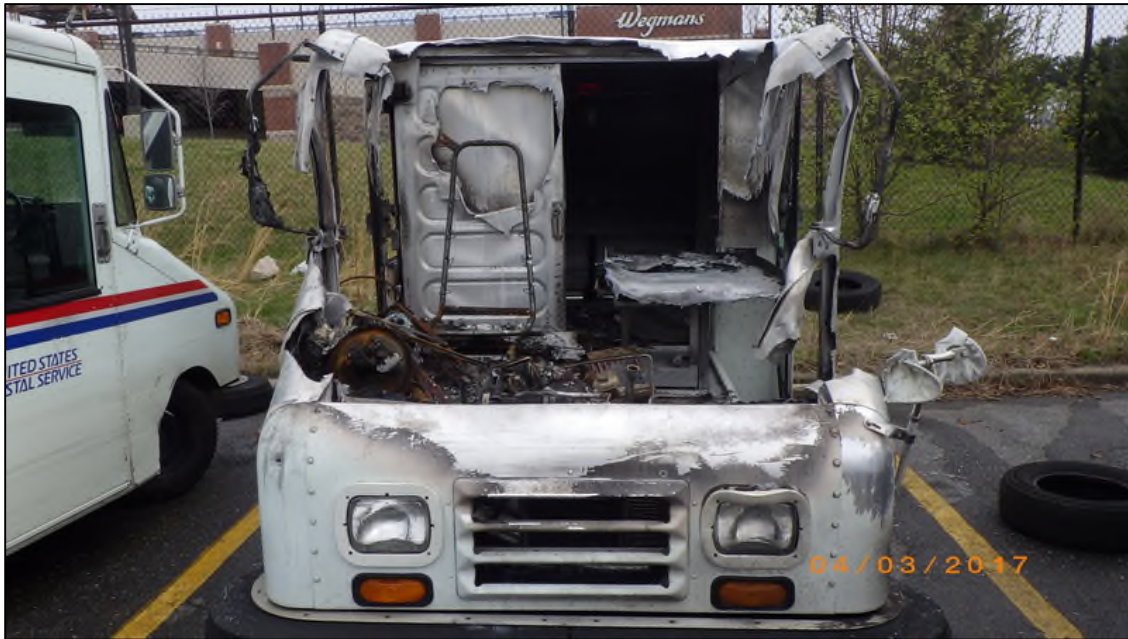
Photograph 1

A view of the exterior front of the vehicle.

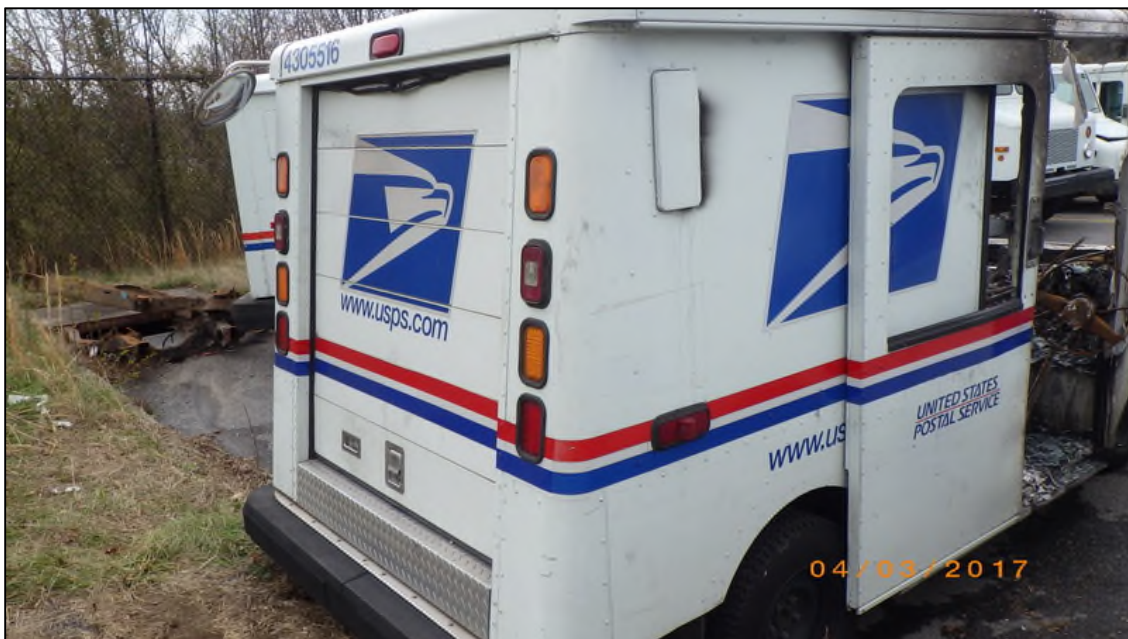
Photograph 2

The rear of the vehicle.

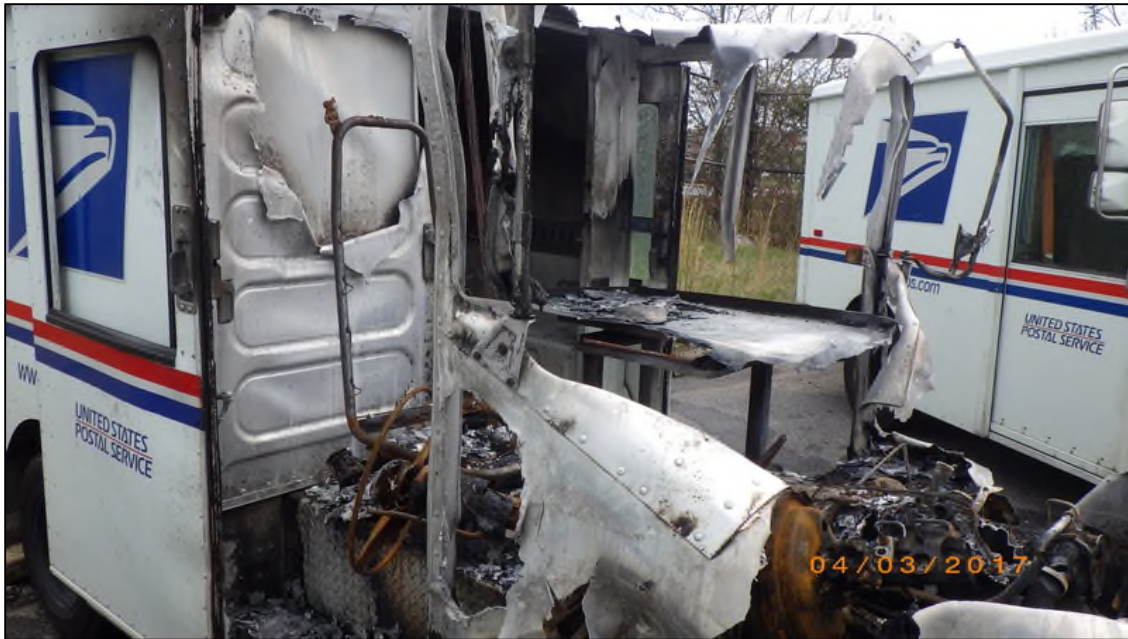
Photograph 3

A view of the driver's side and dashboard area, observe the mass loss to the area.

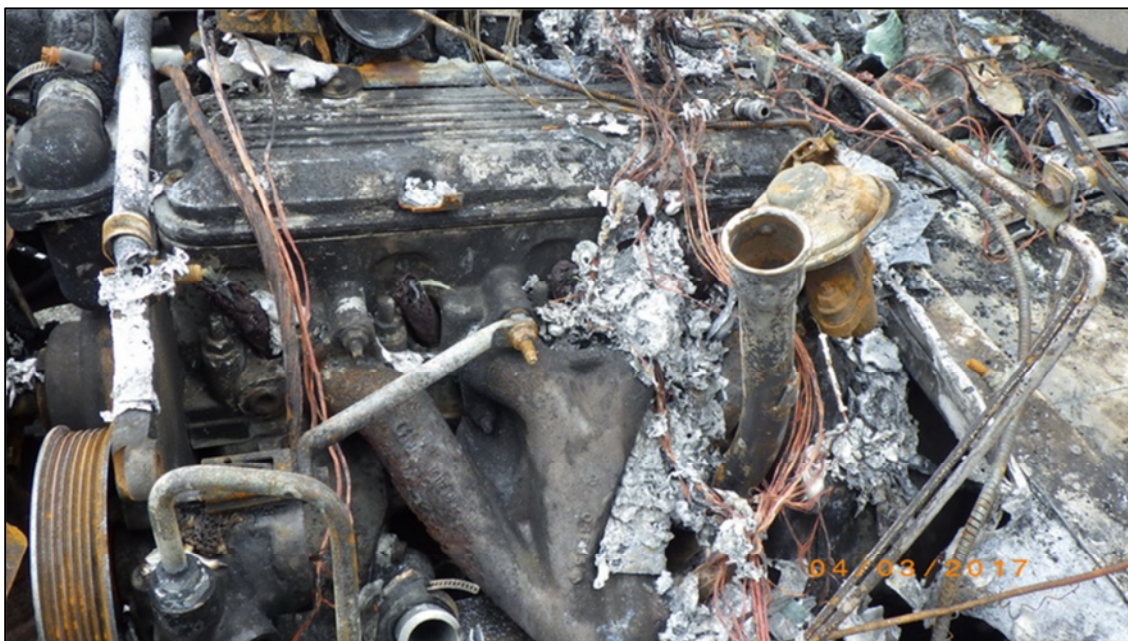
Photograph 4

A view of the left side of the engine compartment.

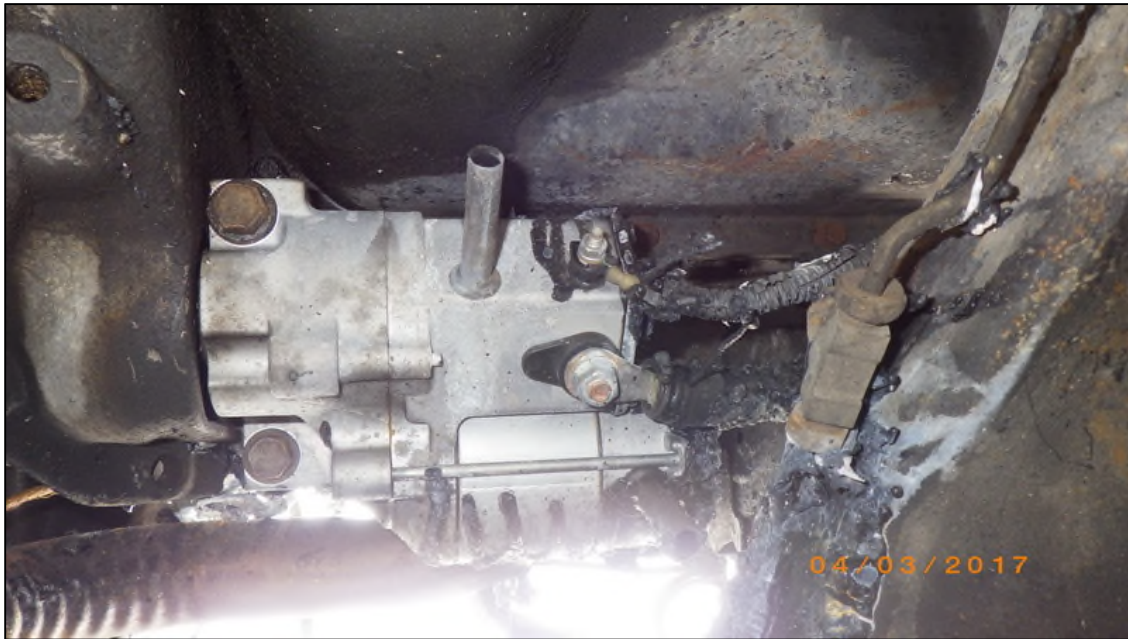
Photograph 5

A view of the left side of the undercarriage at the starter.

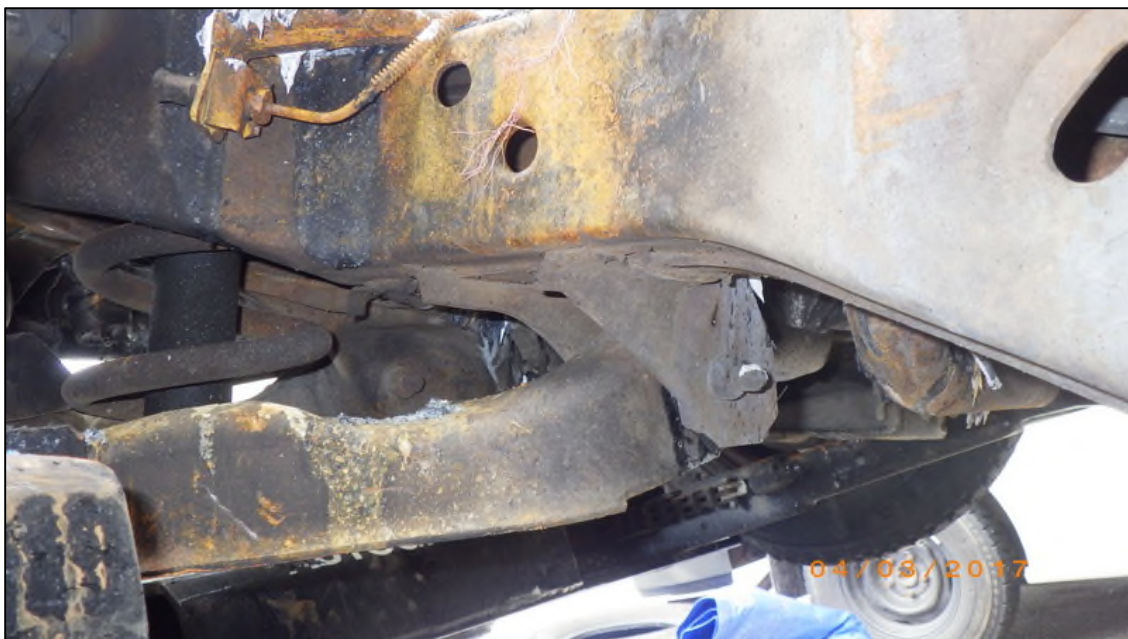
Photograph 6

A view of the left side frame above the starter.

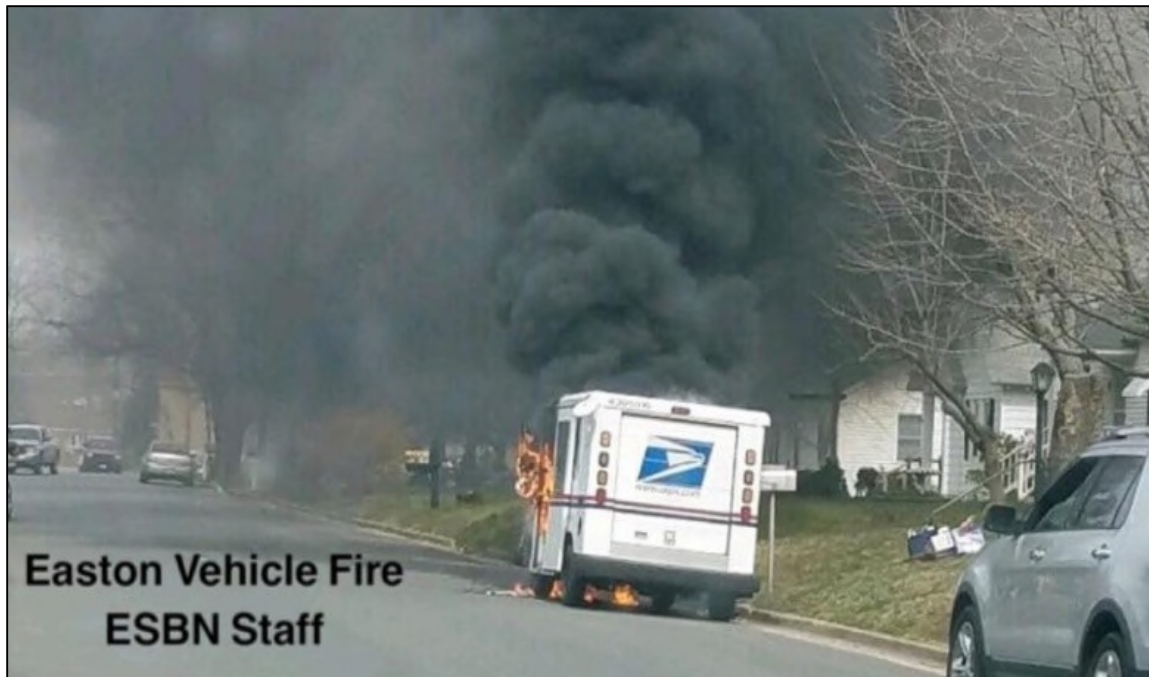
Photograph 7

Photo taken during fire event (Provided by USPS).

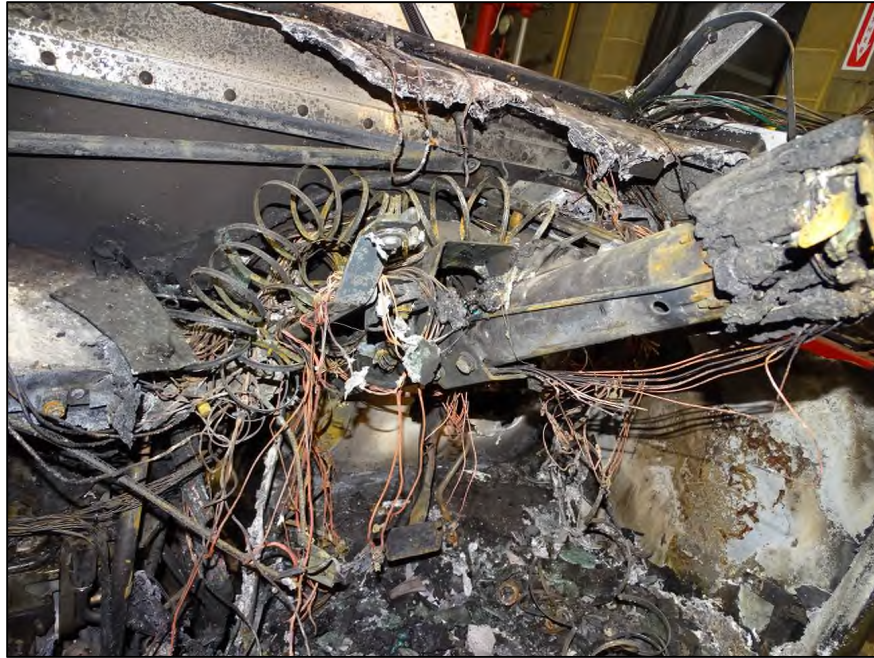
Photograph 3

Examination of the interior of the vehicle revealed severe fire damage to the operator's compartment and smoke staining to the cargo area. Minor fire damage was observed in the cargo area. The most severe fire damage and mass loss was observed to the dashboard area, firewall, and steering wheel assembly. An analysis of the observable fire patterns indicated that the fire originated in this area at or around the headlamp switch positioned in the left side of the dashboard.

Fire damage to left side of dash.

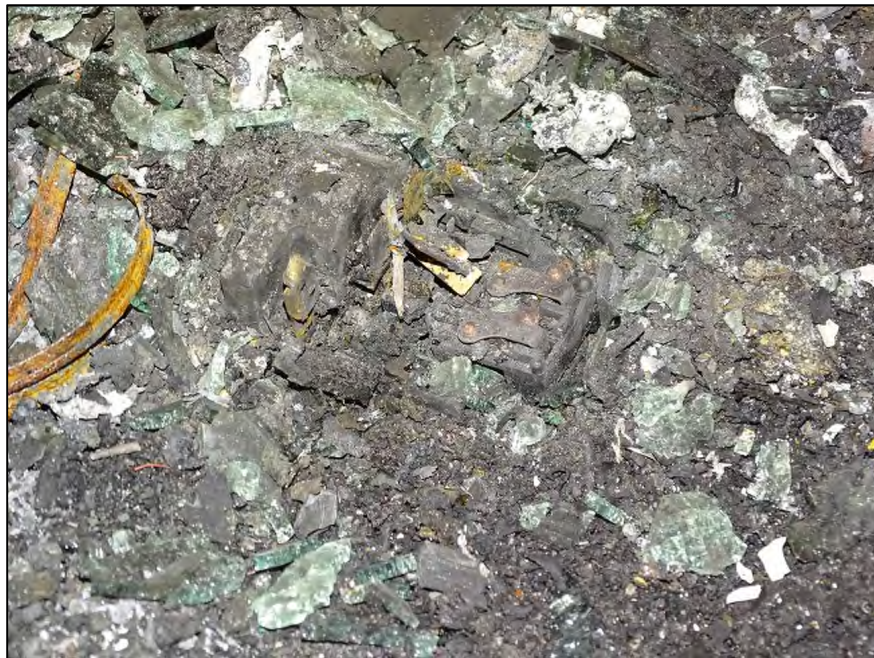
Photograph 4

3. The specific ignition sequence and cause of the fire was determined to be the direct result of a failure of the rheostat switch within the headlamp switch which heated and ignited surrounding combustible material.

The LLV reportedly was being driven at the time of the fire. The headlamps were in the "on" position per policy. An electrical event within the switch caused it to heat and ignited surrounding combustible materials.

Remains of headlamp switch.

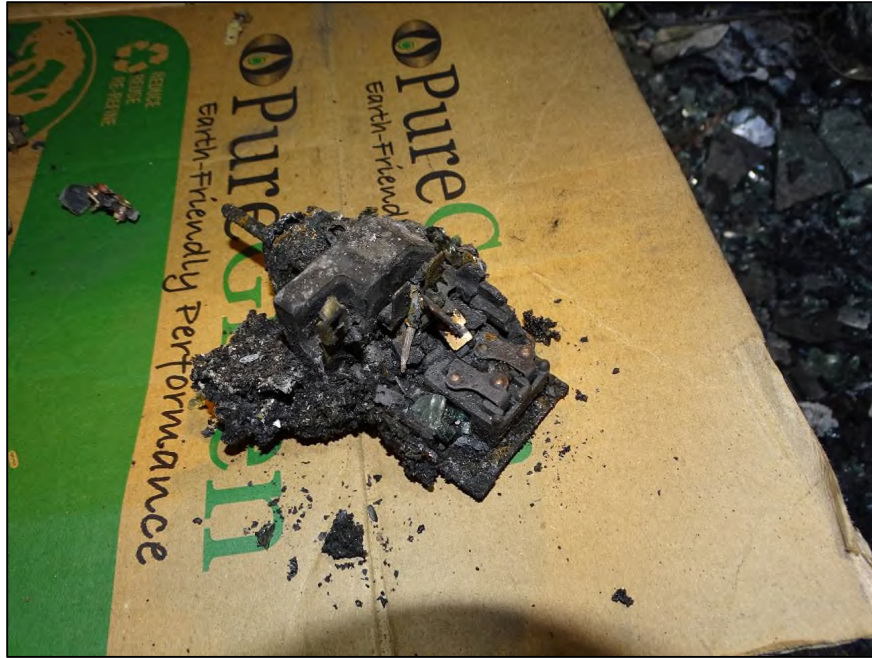
Photograph 5
Damage to headlamp switch.

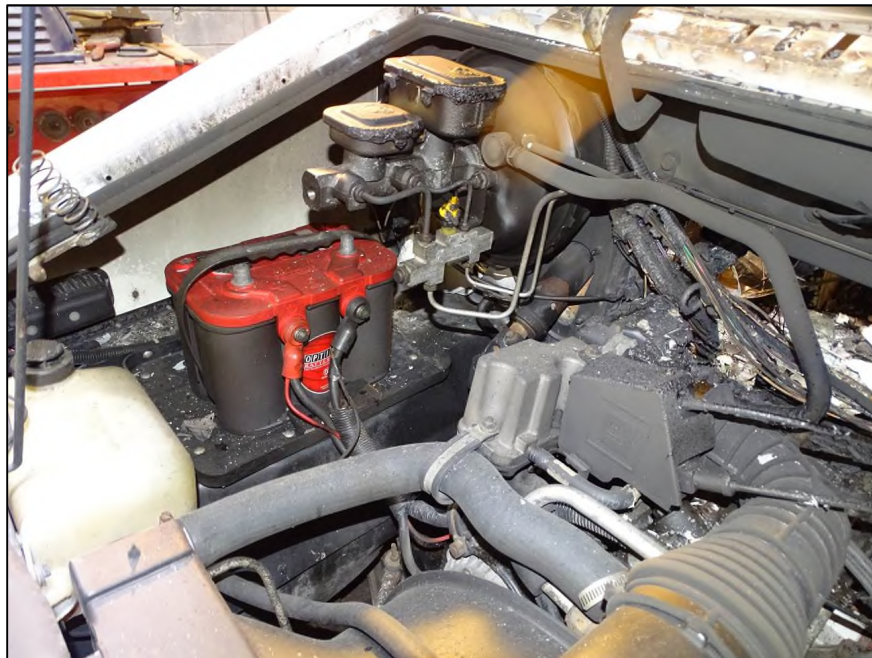
The engine compartment was examined. The vehicle was equipped with a GM 2.2L gasoline engine. No fire damage was observed within the engine compartment. The fuel filter system was the GM model. The involved LLV was not equipped with a High Energy Ignition (HEI) distributor.

Photograph 6
Overall view of engine compartment.

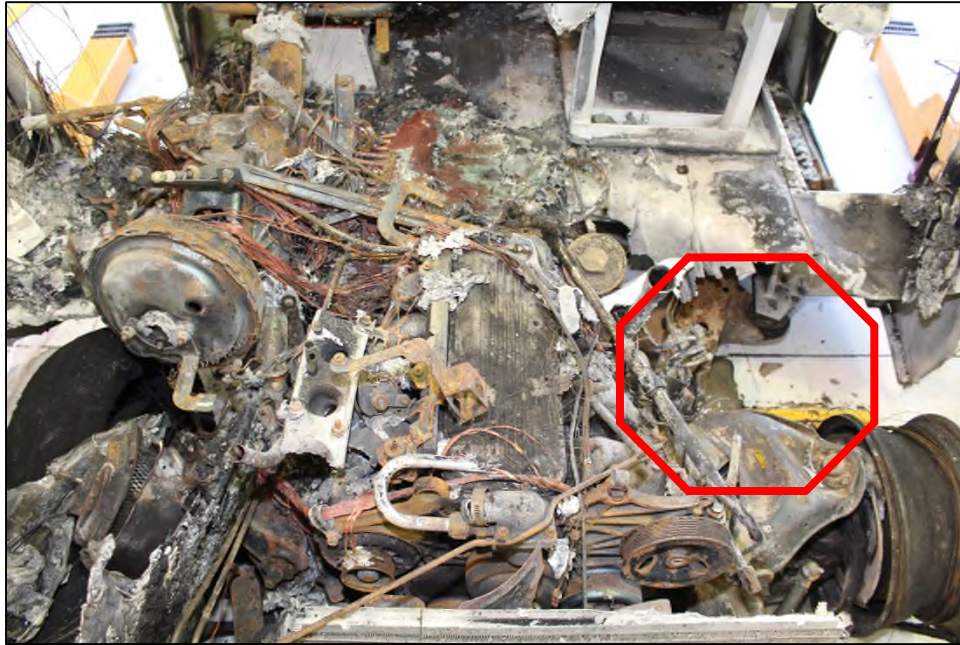
Photograph 3

The greatest fire damage was observed on the left side of the engine compartment.

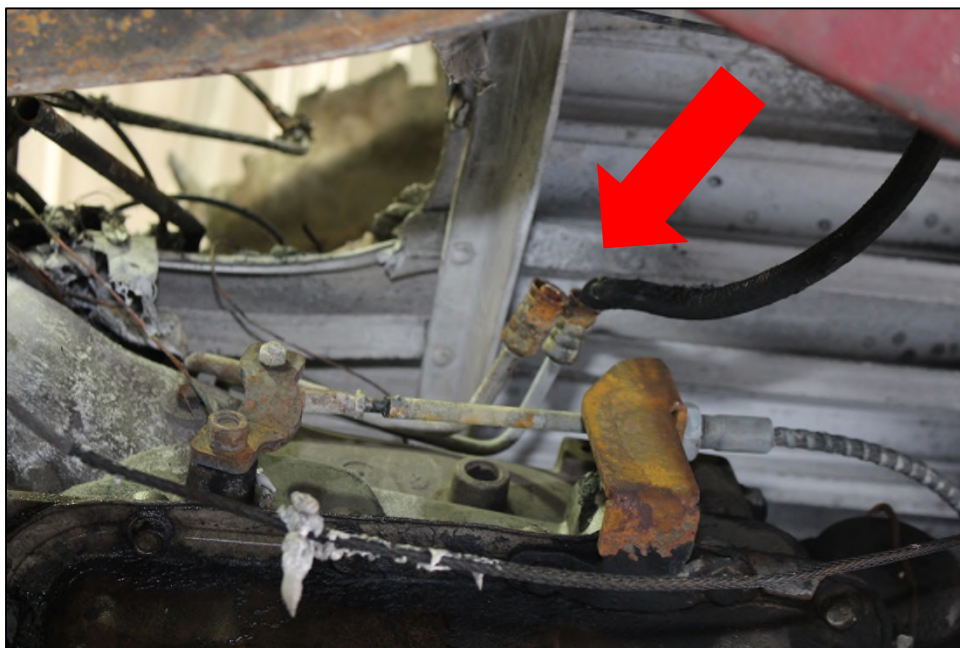
Photograph 4

View of the position of the fuel lines from the undercarriage.

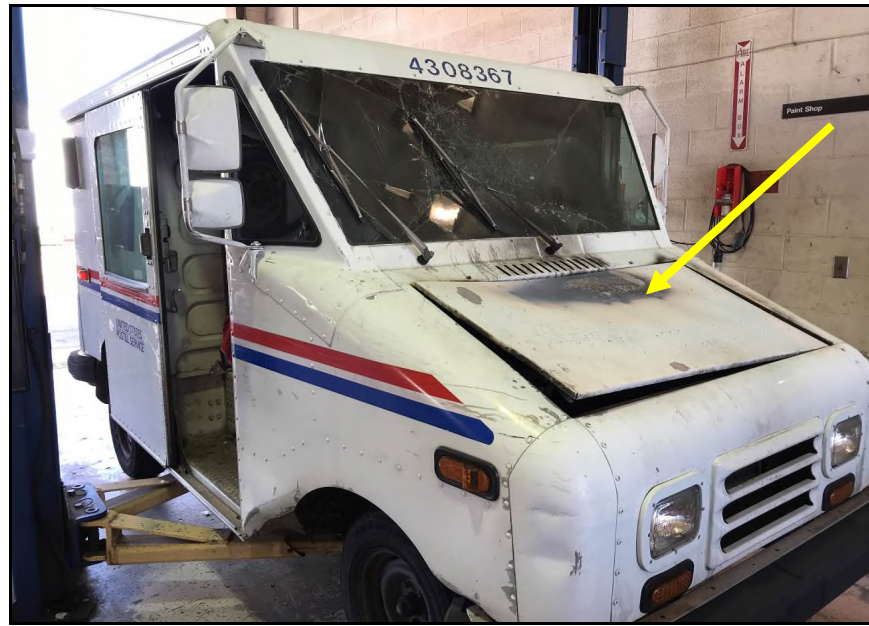
Photograph 1

Side profile view of vehicle; fire intensity and heat stress pattern visible on closed engine hood indicating origin of fire inside the engine compartment.

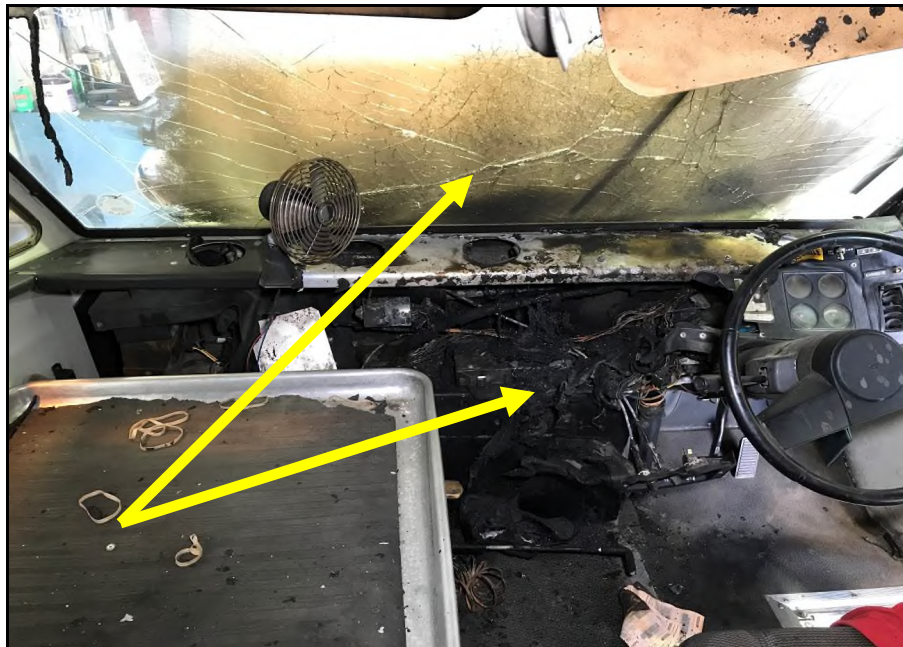
Photograph 2

Interior view of vehicle showing penetration of fire through bulkhead with corresponding thermal fracture of the front windshield directly above the dash console area.

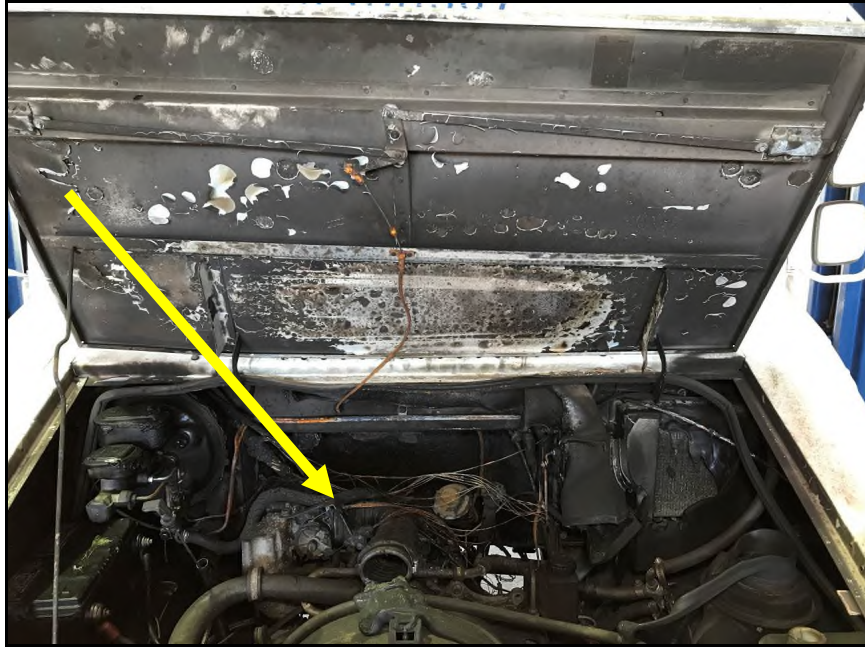
Photograph 3

Engine compartment; area of fire origin involving failure of ignition module is indicated with arrow.
